KOOTENAI DEVELOPMENT IMPOUNDMENT DAM

ANNUAL OWNERS INSPECTION REPORT

BILLMAYER ENGINEERING

MAY 23, 2007

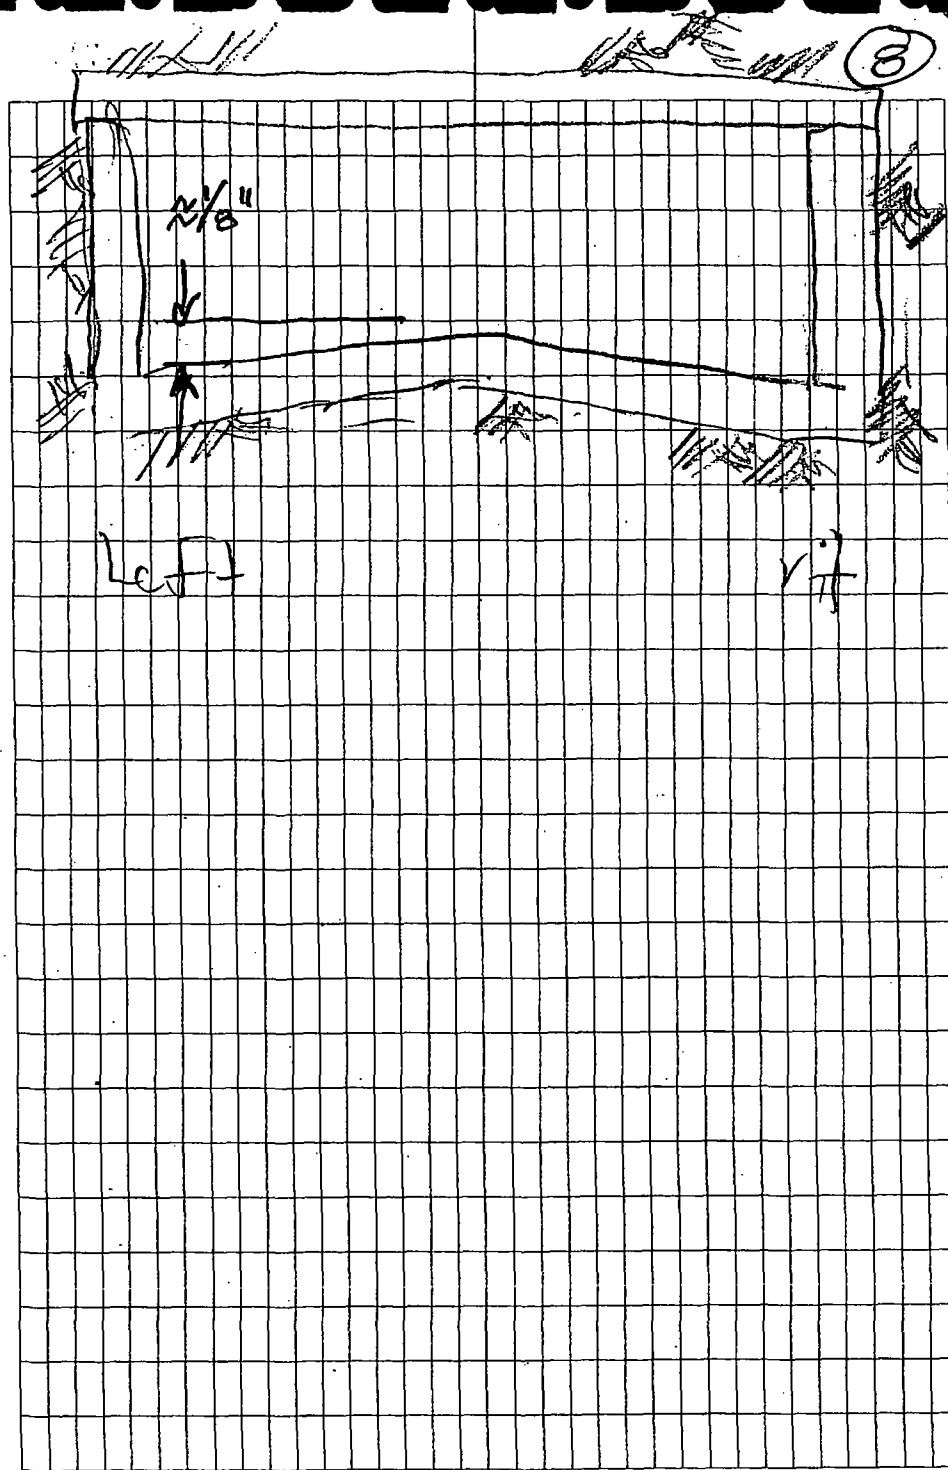
(9)

- middle of spillway
bottom of spillway
appears bowed up
slightly
- open chute spillway
 - some cracks in
side walls
- Floor good
- some wobbles at
base of chute, const
detect
- some missing chunks out
of wall tops
- conc. sound.

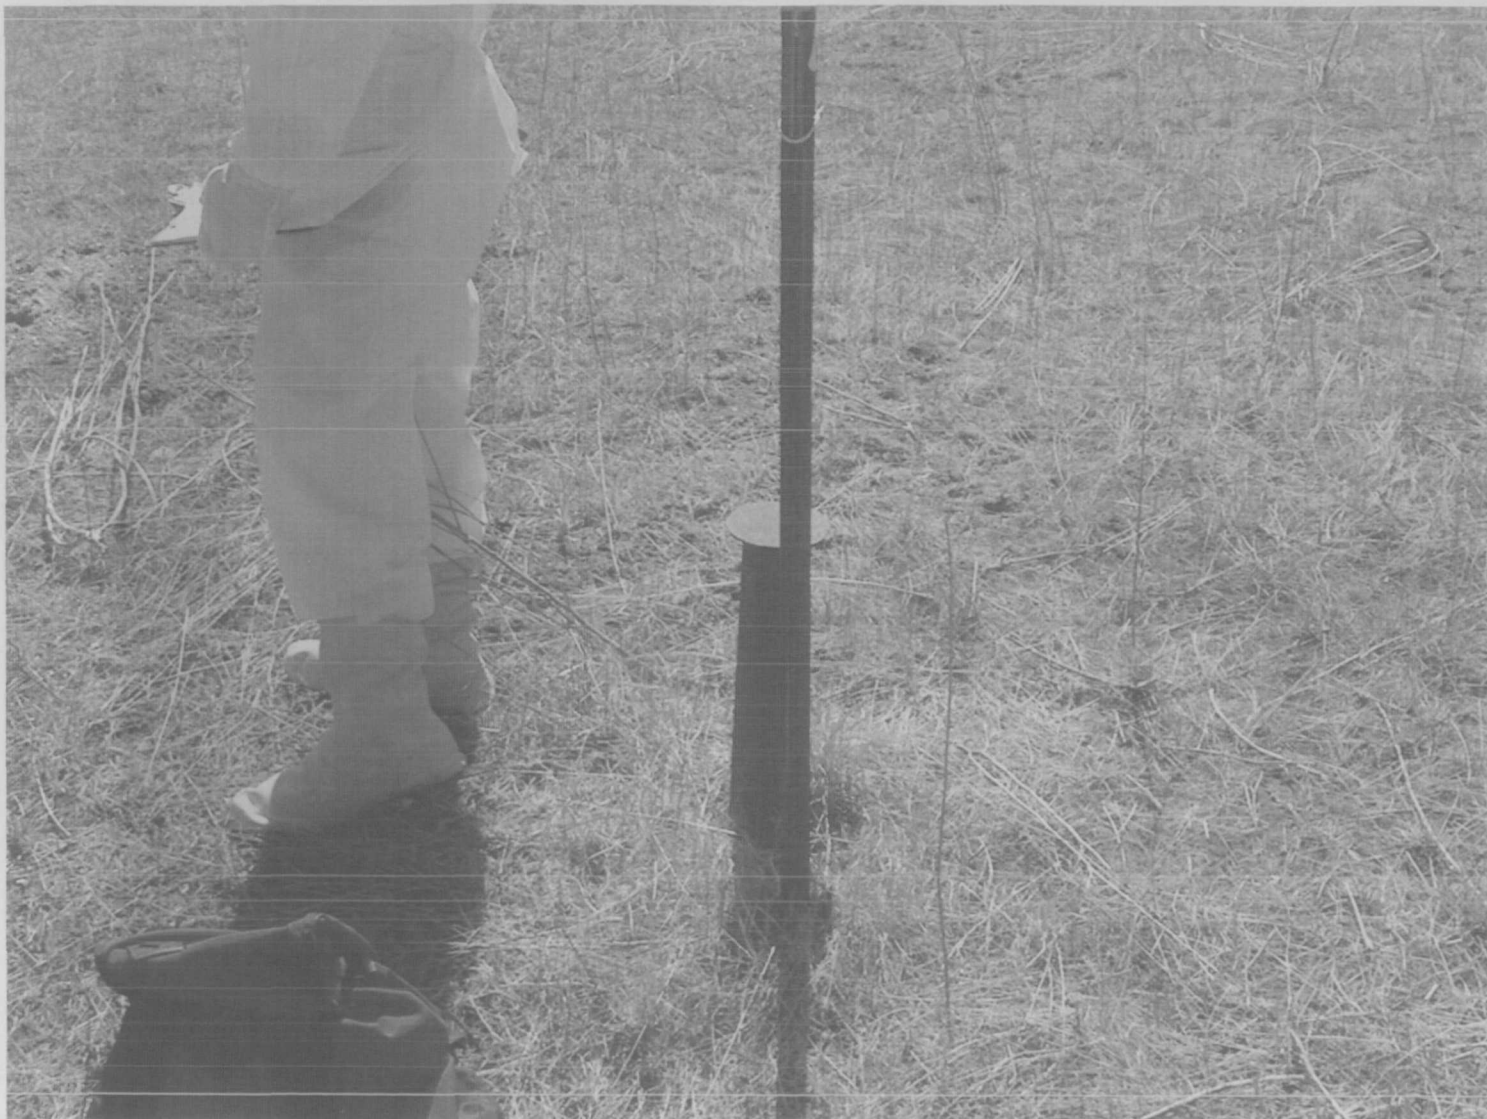
The section of the Piezometer casings that are above ground were in good condition and all of the piezometer casings were open and unobstructed to the bottom. Photographs of piezometers P1, P3, and P4 are shown in Exhibit 3, page E3-3, E3-7 and E3-8.

JEFF ROBERTSON AT PIEZOMETER P1

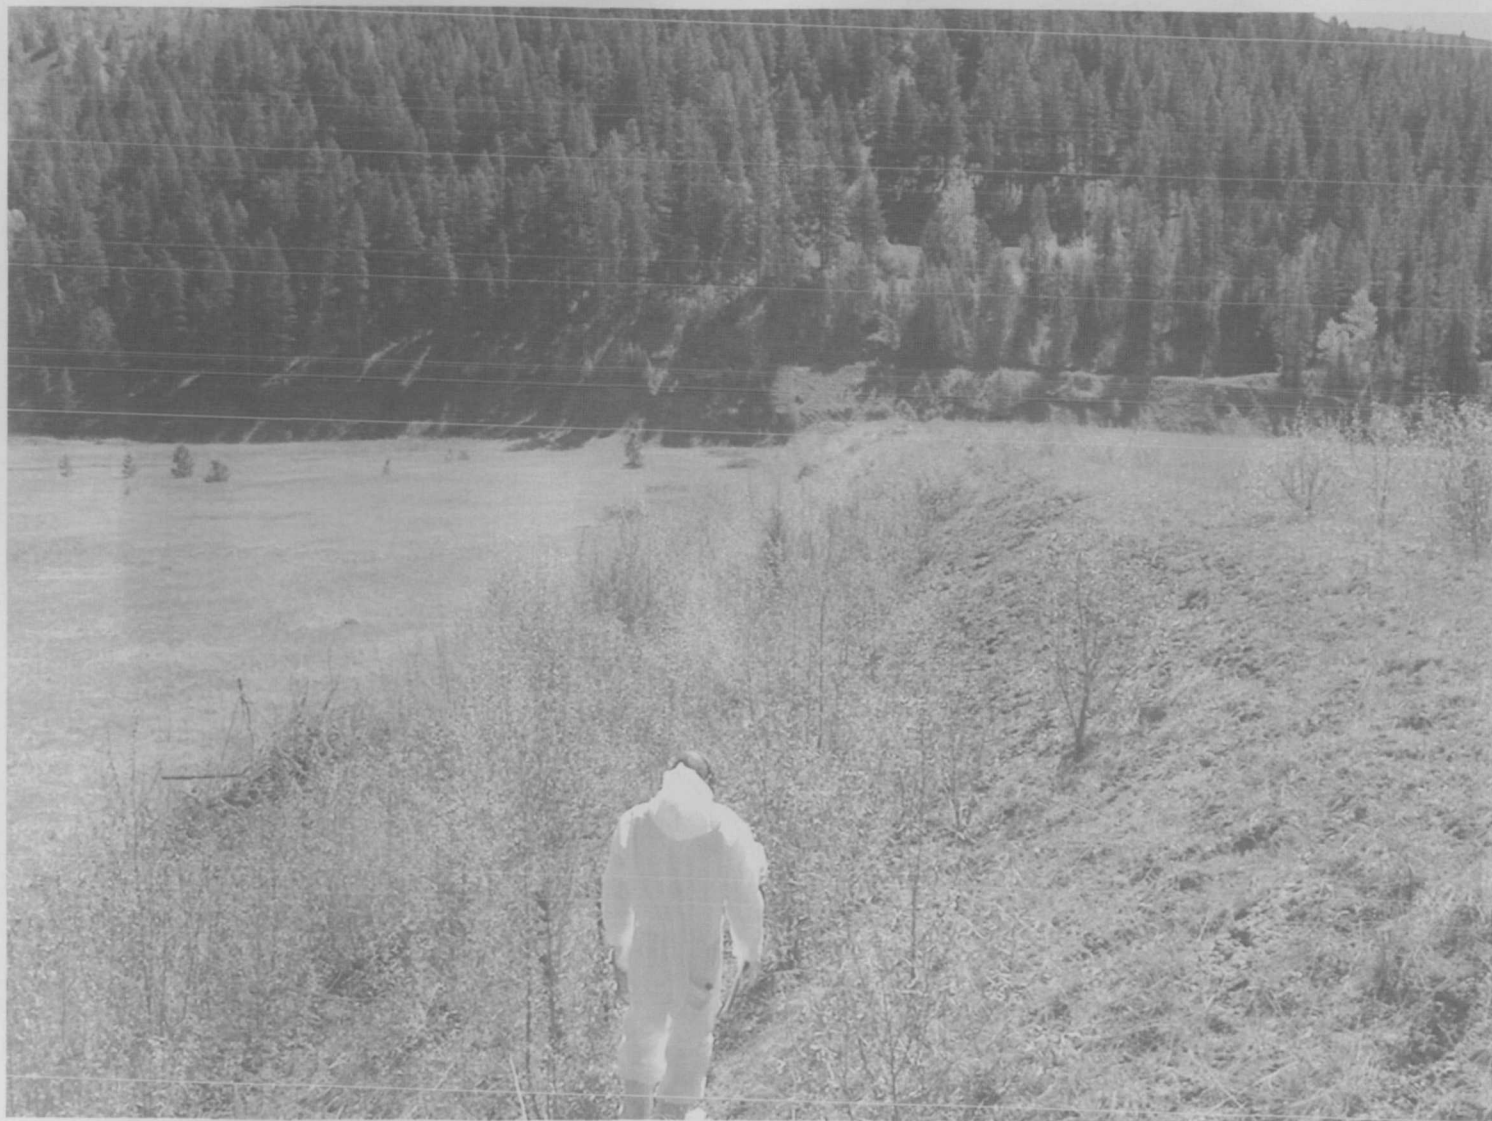
E3-5

The upstream face of the dam was inspected from the right to the left side. There was no misalignment, bulges or depressions noted in the upstream face. There are a number of small cottonwoods, a couple of small pine trees, and some weeds growing all along the upstream face of the dam. A photograph of the upstream face of the dam from the right side looking to the left side is shown on page E3-5, a photograph taken from the reservoir looking southwest is shown on page E3-10, and a photograph looking from the left side to the right is shown on page E3-8.

UPSTREAM FACE OF EMBANKMENT AND EDGE OF CREST

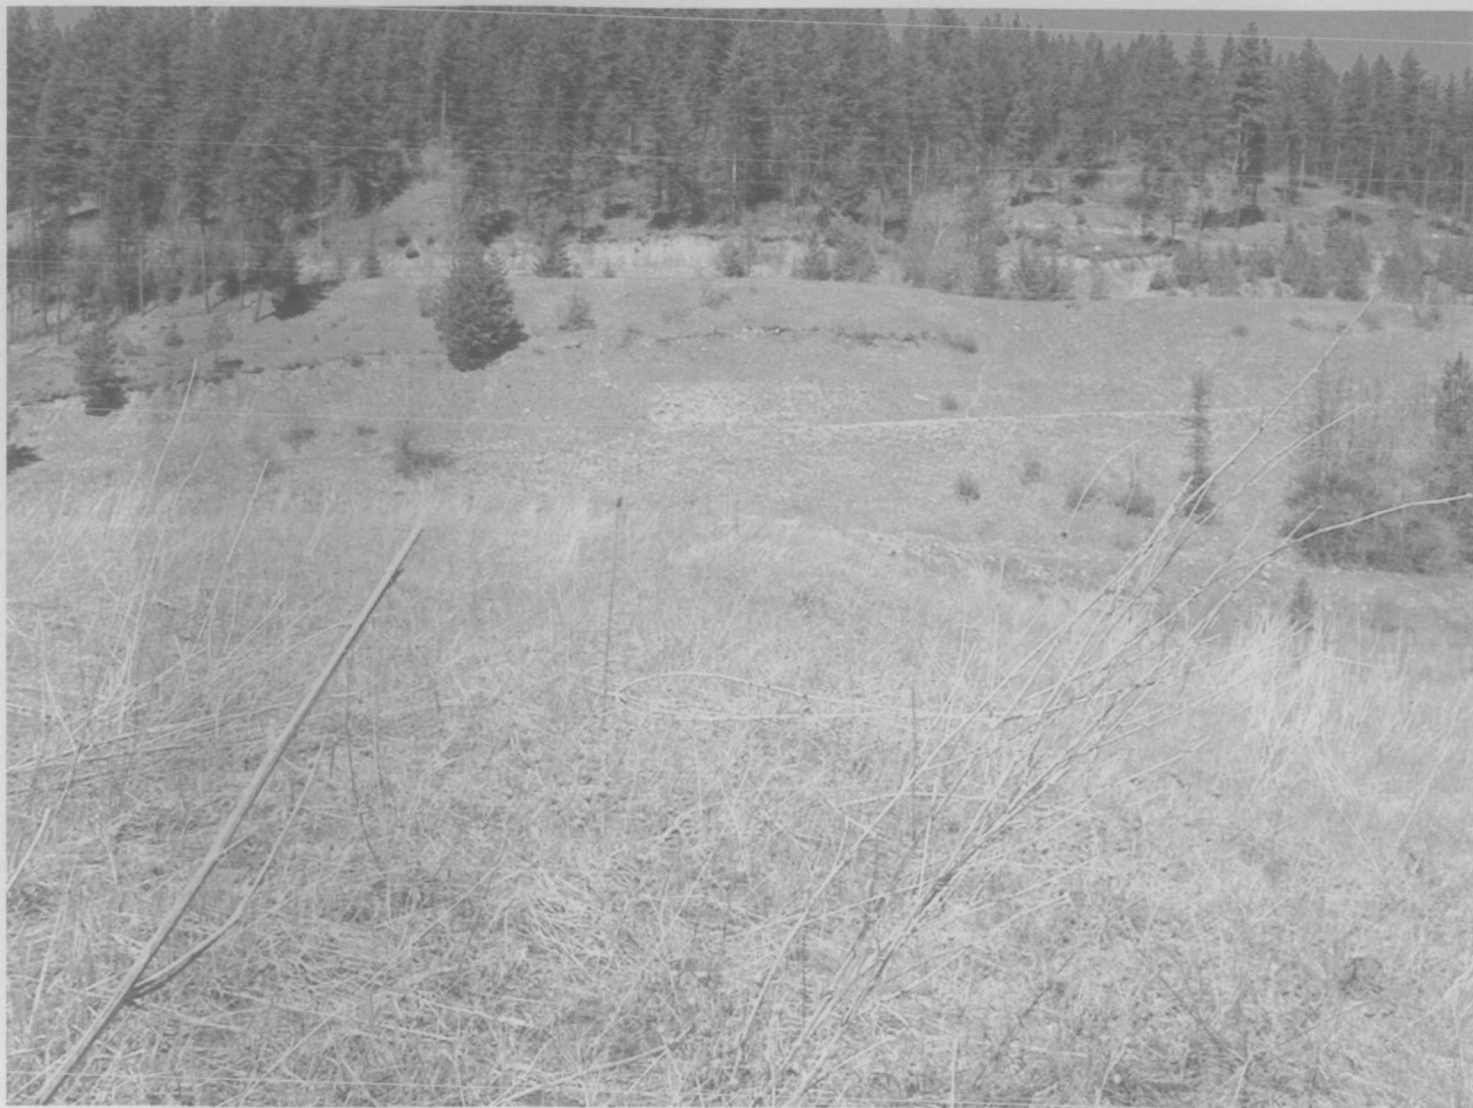
E3-6

The crest of the dam was inspected from the right to the left side. There was no misalignment, bulges or depressions noted in the crest. There were some small cottonwoods growing on the upstream edge of the crest near the middle of the embankment, otherwise there was no other vegetation growing on the crest that was of concern. A photograph of the upstream edge of the crest from the right side looking to the left side is shown on page E3-5 and a photograph taken from the reservoir looking southwest is shown on page E3-10. A small berm, approximately 1 foot high, running the length of the crest, was notice on the upstream face. It was also noted that there were two areas on this berm where there were piles of rocks and debris that had been dumped on the crest on the upstream edge in random piles.

CREST OF EMBANKMENT LOOKING NORTHWEST

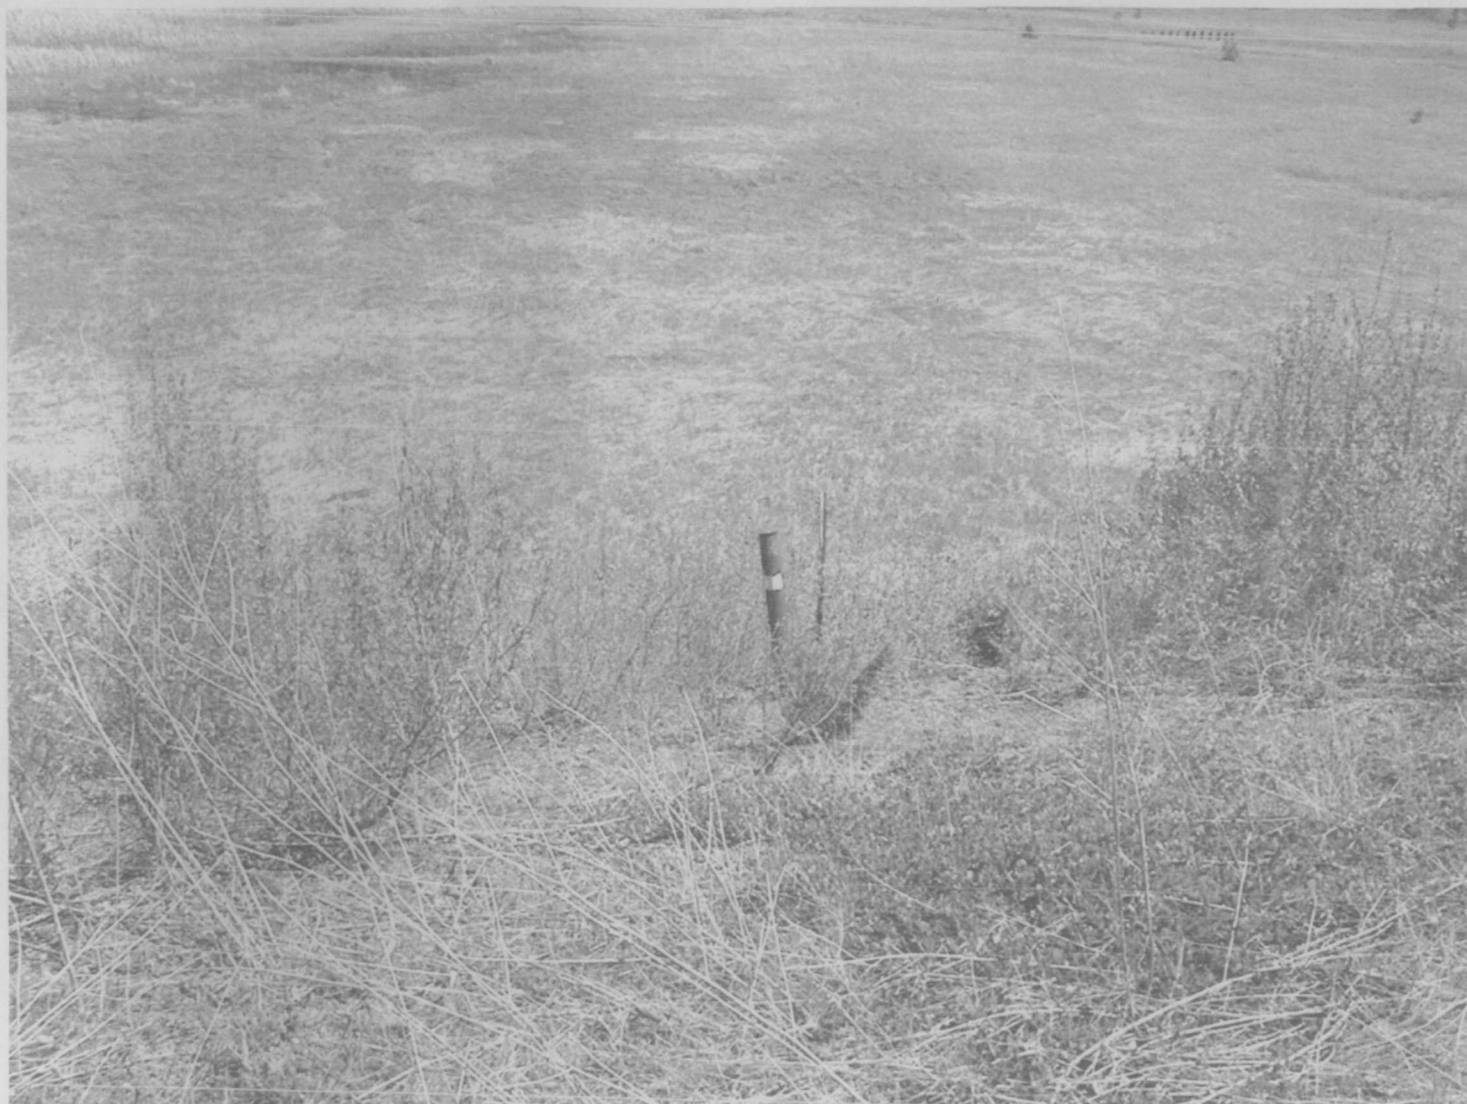
E3-7

PIEZOMETER P3

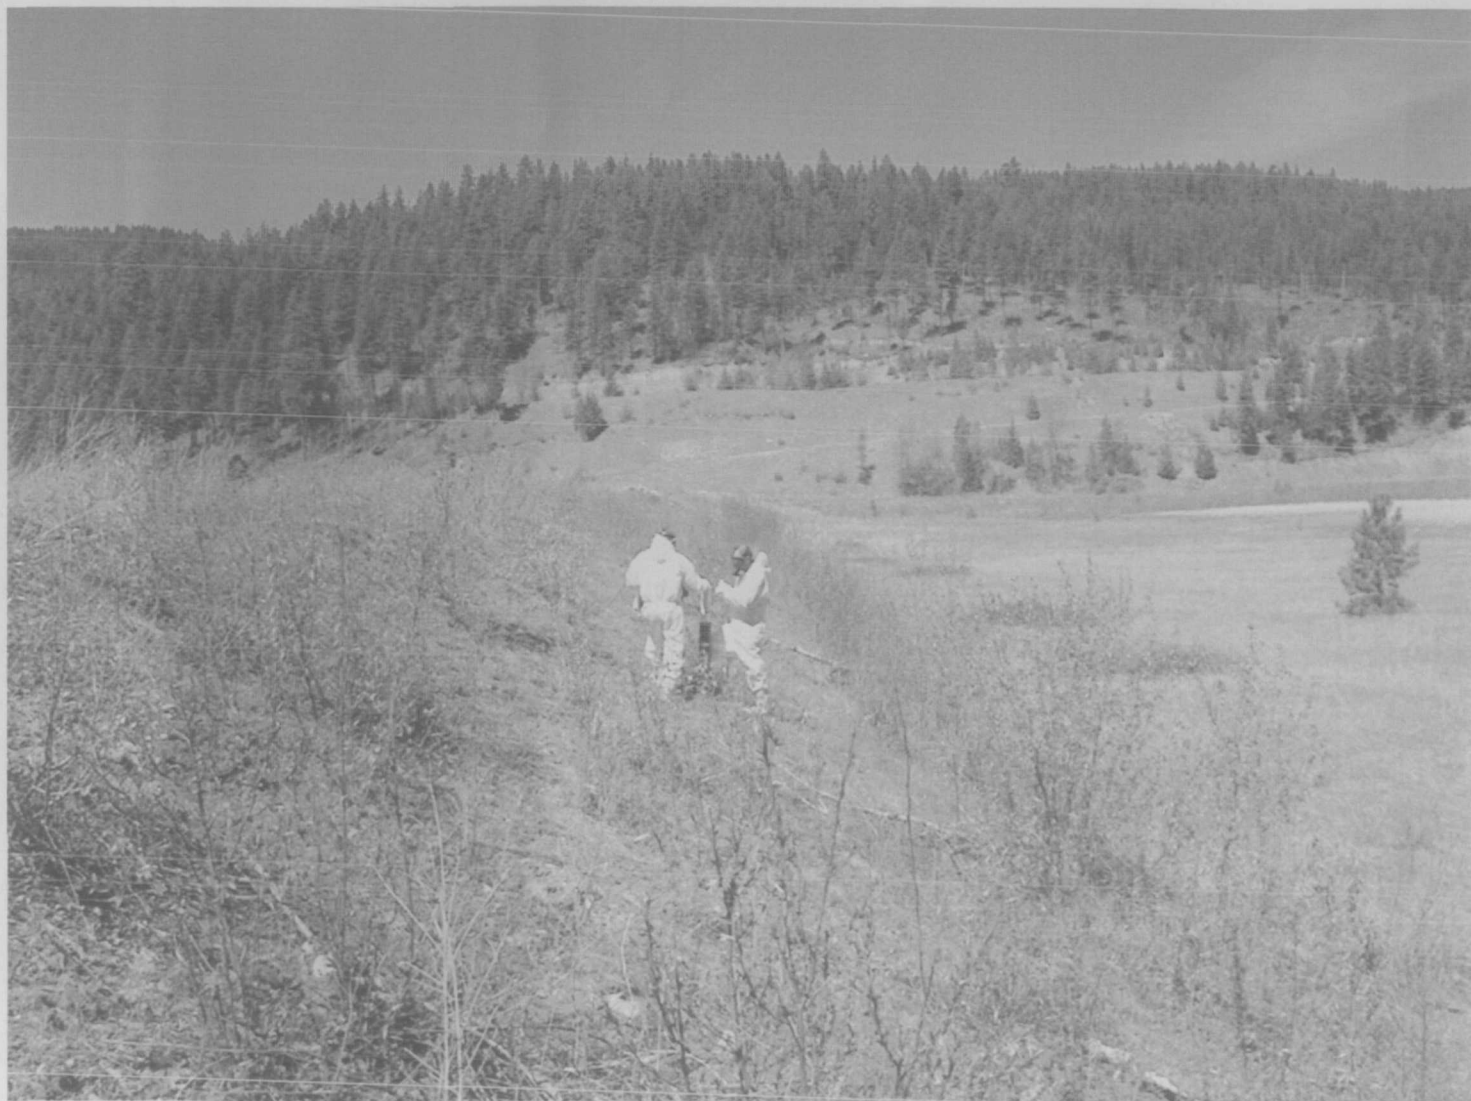
E3-8

JAY BILLMAYER AND JEFF ROBERTSON AT PIEZOMETER P4

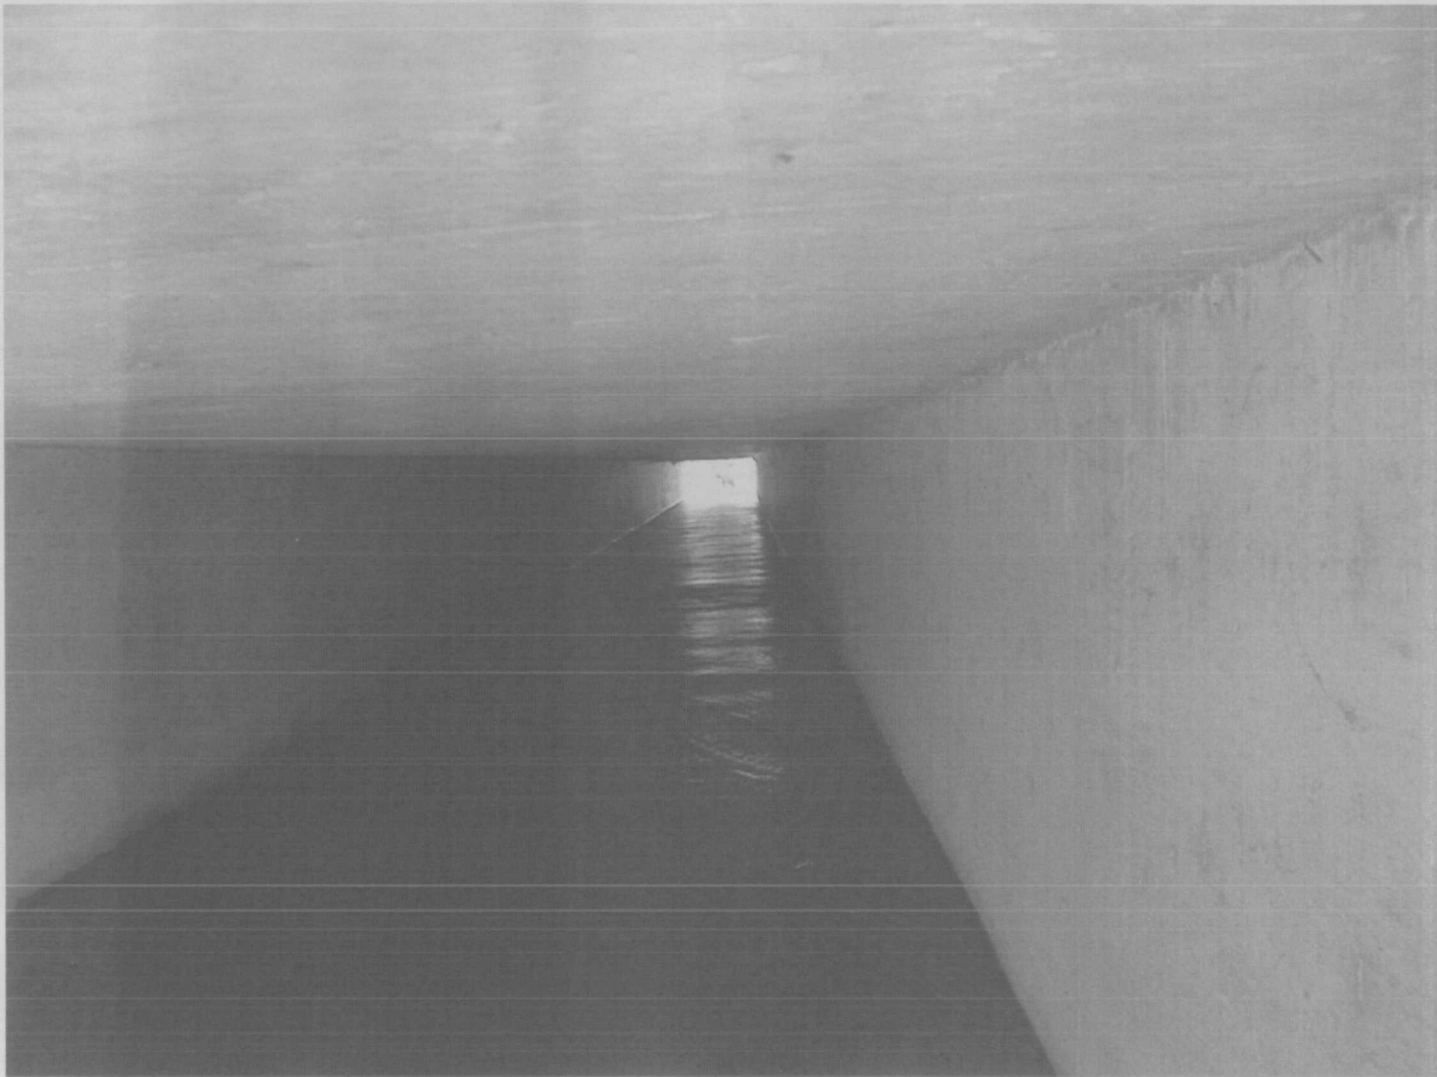
E3-13

The earthen channel leads to the entrance of the box culvert. The entrance is shown on page E3-12. The water depth flowing in the box culvert was approximately 0.05 feet on the day of the inspection. The entry to the box culvert was noted as being in good condition with riprap protection on both sides. There were two large rocks that had rolled into the left side of the entry channel to the box culvert as shown on page E3-15. There was a 6-inch long piece of concrete that had been broken off of the lip of the entry at the invert of the box culvert as shown on page E3-14.

INSIDE BOX CULVERT AT ENTRANCE

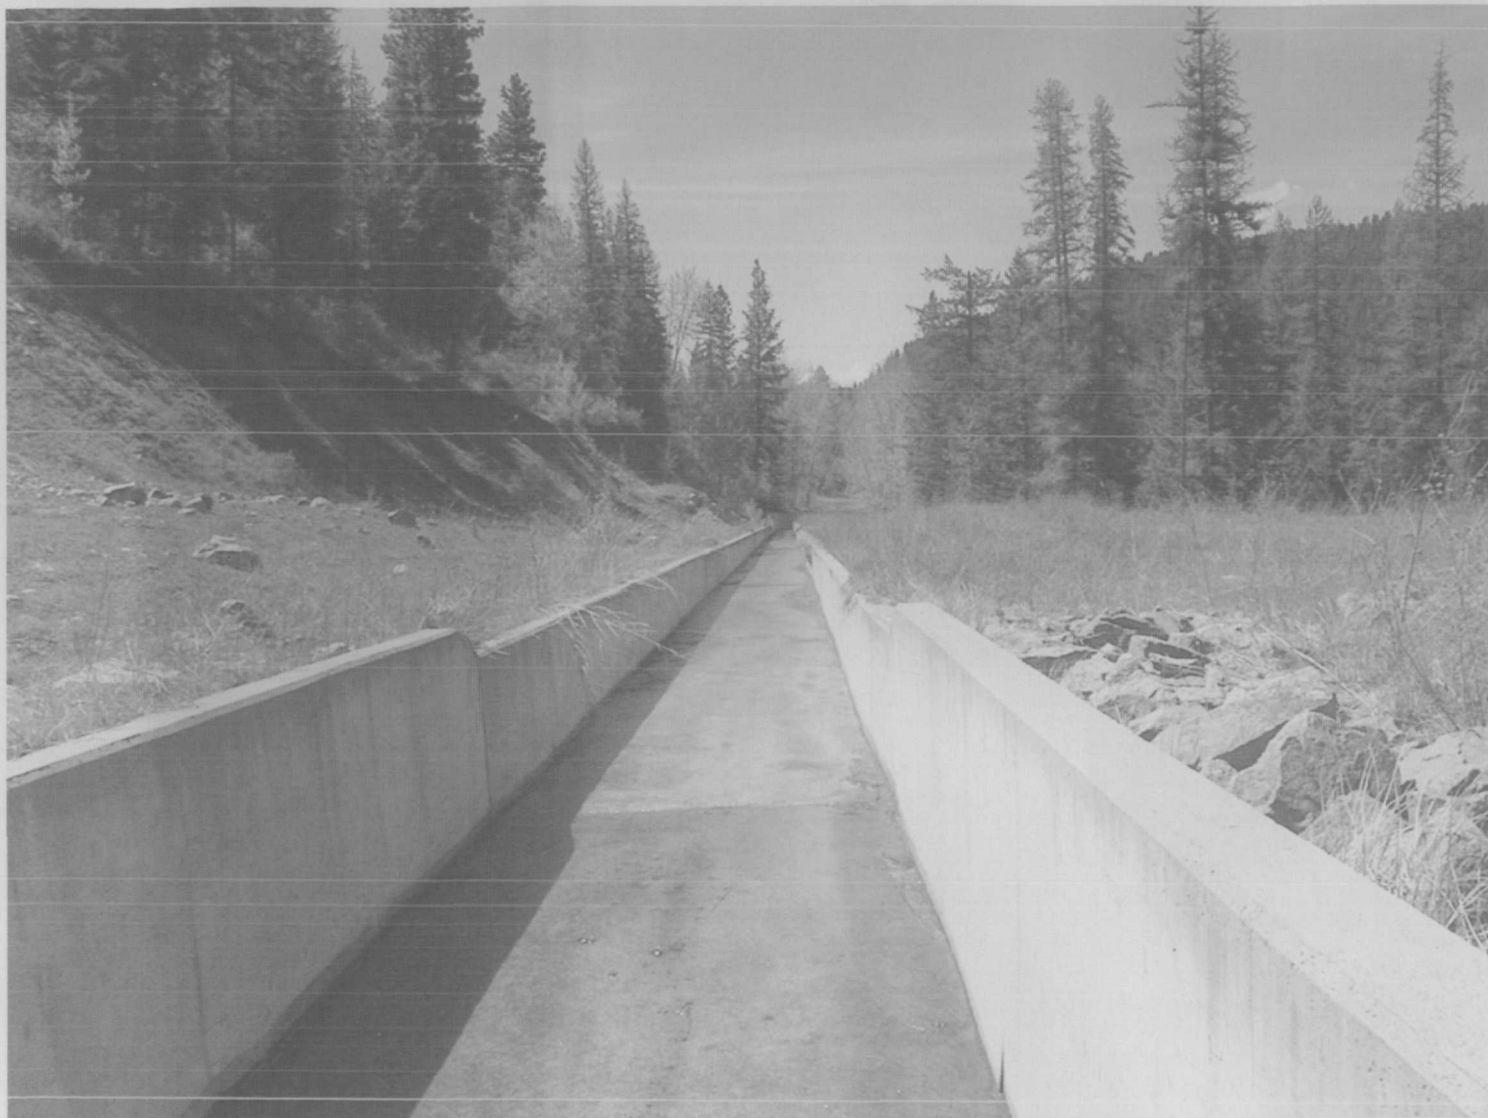
The open chute spillway was inspected from the outlet of the box culvert to the top of the steep section of the chute. Photographs of the open chute and steep open chute section are shown on pages E3-23 to E3-29. The open chute was in good condition over most of the length. There are some 1/16th inch cracks in the left sidewall that run vertically from the top to the bottom and appeared to be either settlement cracks or may be sidewall load cracks. They appeared at unequal intervals along the wall and were only noticed on the left side. A photograph of one of the cracks is shown on page E3-24. It was also noted that there were several different sections on the top of the open chute walls where pieces of the wall top had spalled or cracked off. Most of the pieces

CONCRETE CHUTE SPILLWAY AT EXIT FROM BOX CULVERT

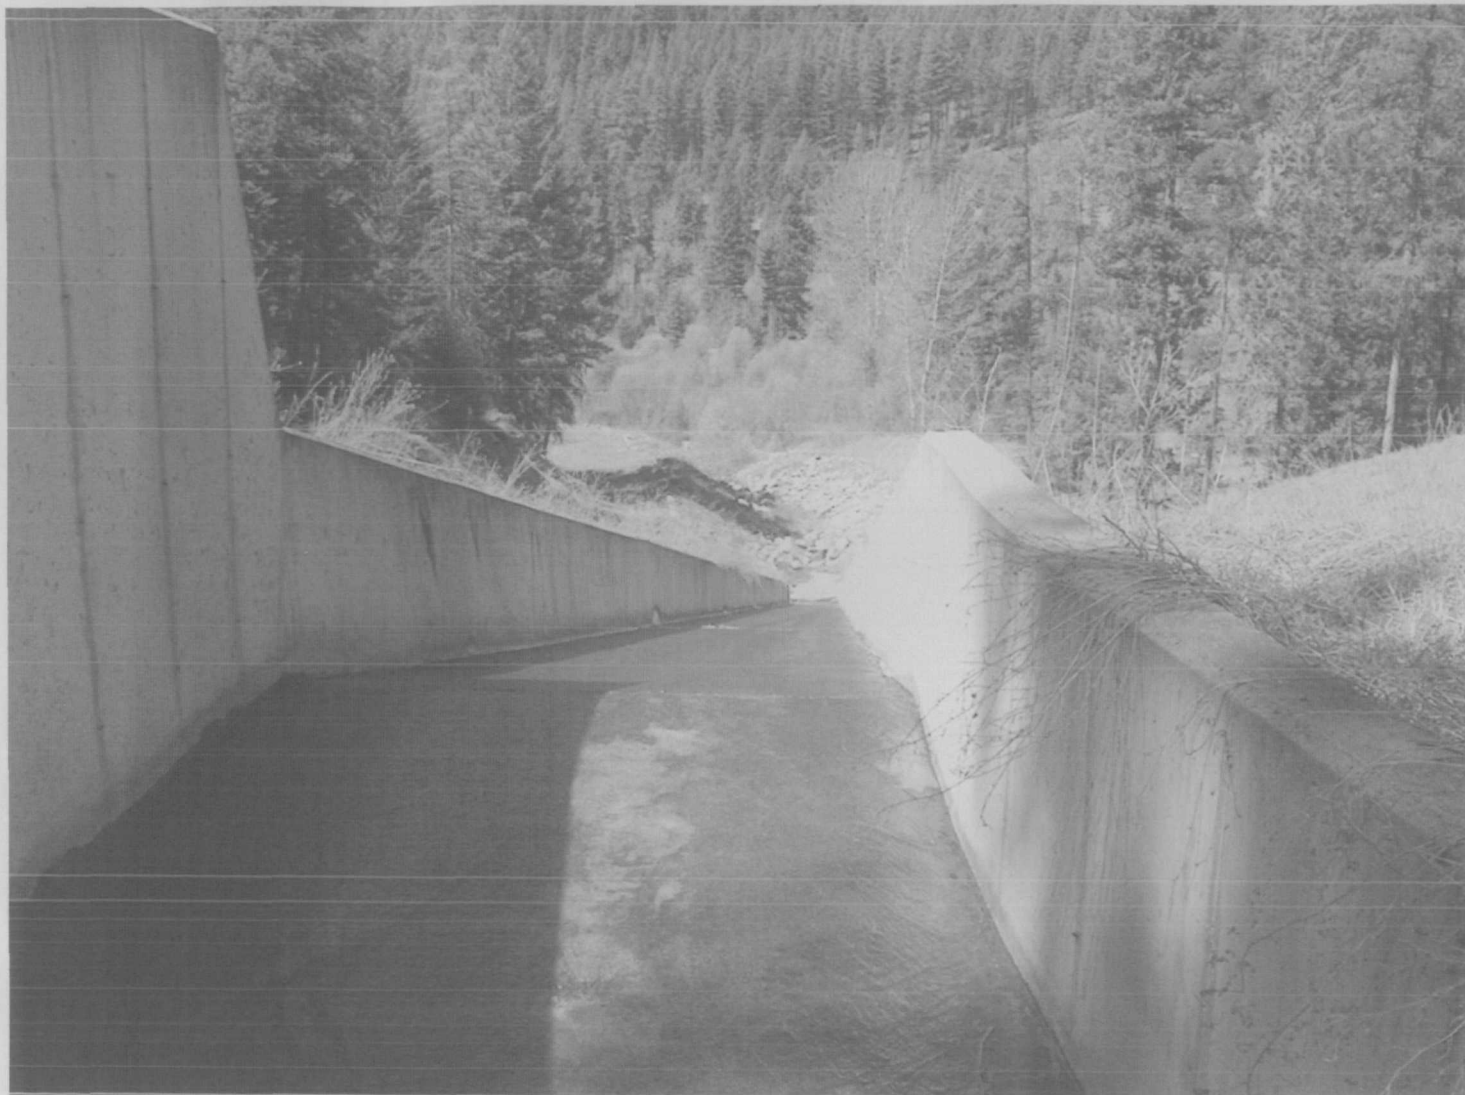
A photograph of the steep section of the open chute is shown on page E3-26 and E3-27 as taken from the top of the spillway and on page E3-29 taken from the bottom. As there was water running in the spillway and algae on the floor, for reasons of safety, the chute was not inspected. The chute appeared to be in good condition and no cracks, displacements or anomalies were noted as observed from the top or bottom of the spillway.

ENTRANCE TO STEEP SECTION OF OPEN CHUTE SPILLWAY

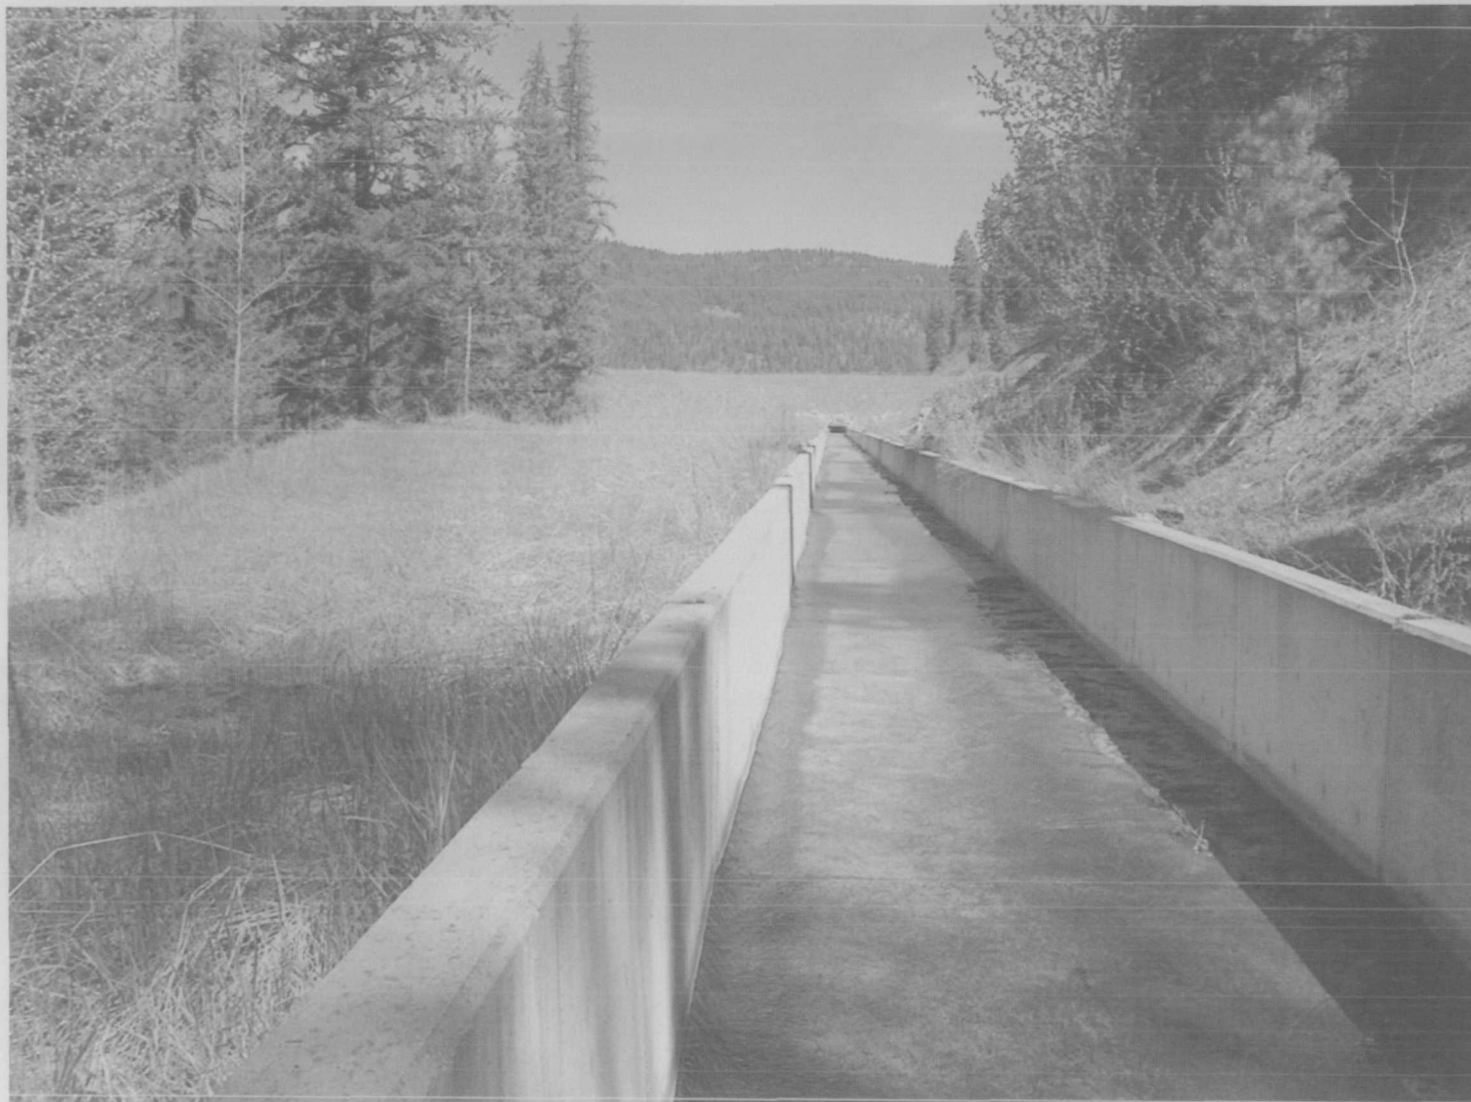
E3-28

CONCRETE CHUTE SPILLWAY LOOKING BACK AT EXIT TO BOX CULVERT
